NBSIR 74-390

ELECTROMAGNETIC NOISE IN ITMANN MINE

Electromagnetics Division
Institute for Basic Standards
National Bureau of Standards
Boulder, Colorado 80302

June 1974

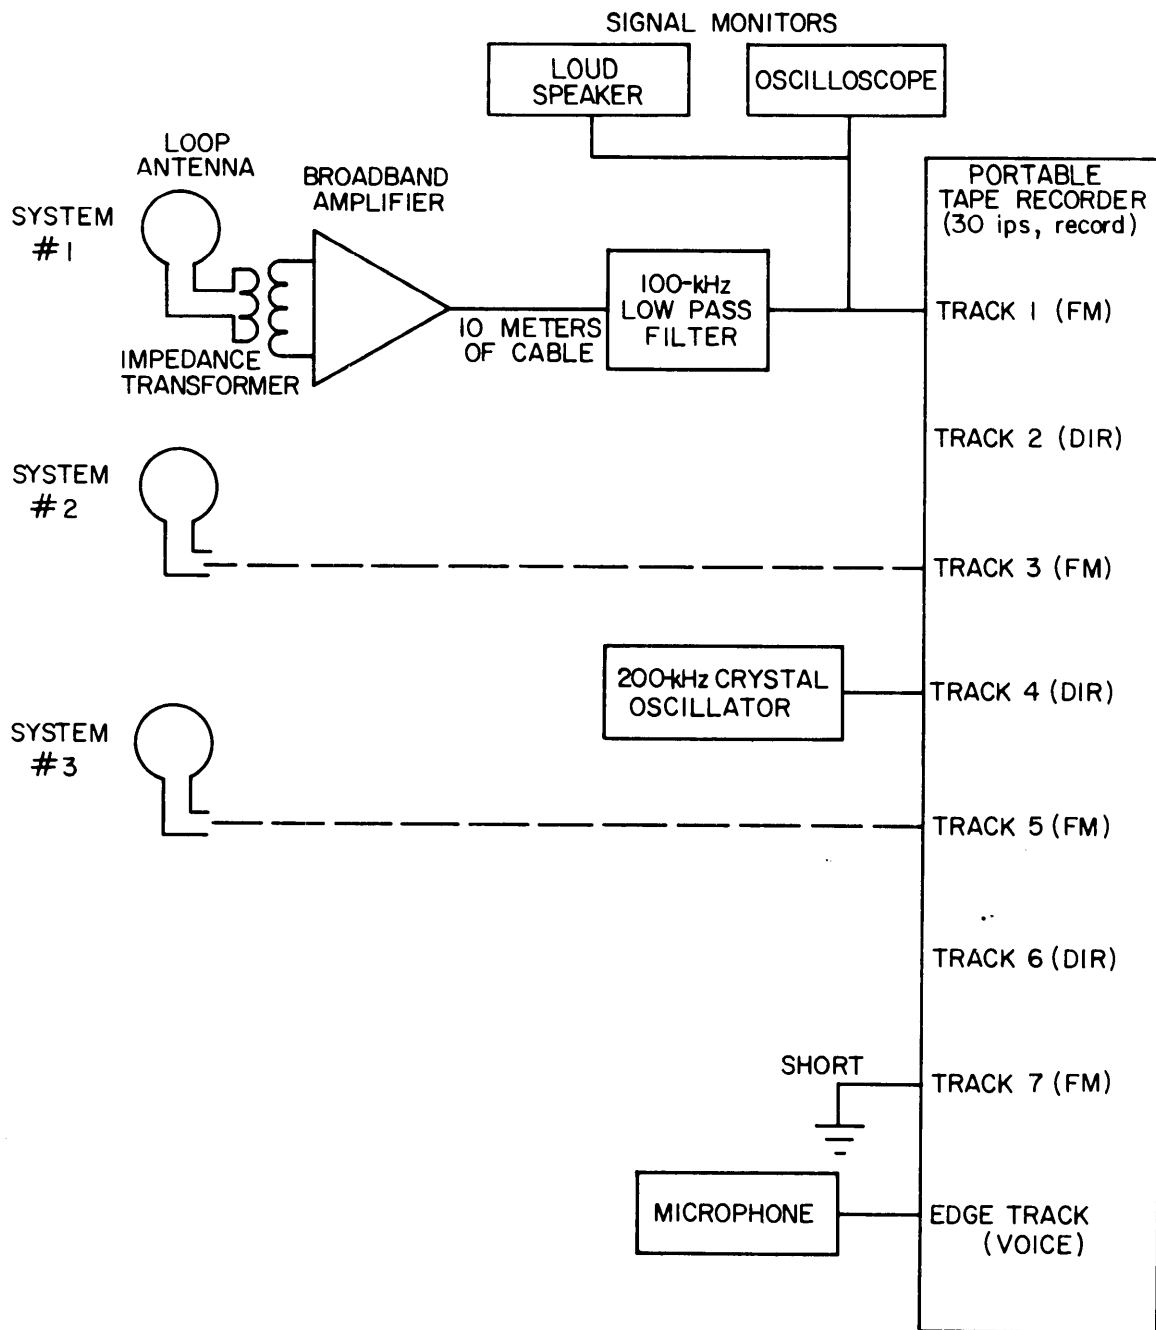
Figure 2-1 Block diagram of portable instrumentation. FM tracks are used to record from 40 Hz to 100 kHz; direct tracks are used from 3 kHz to 320 kHz. Systems 2 and 3 are identical to system 1. When the direct tracks are used, the 100-kHz low pass filters are eliminated, and the amplifier bandwidth is increased from 100 kHz to 300 kHz. The microphone is used for occasional vocal comments by the operator.

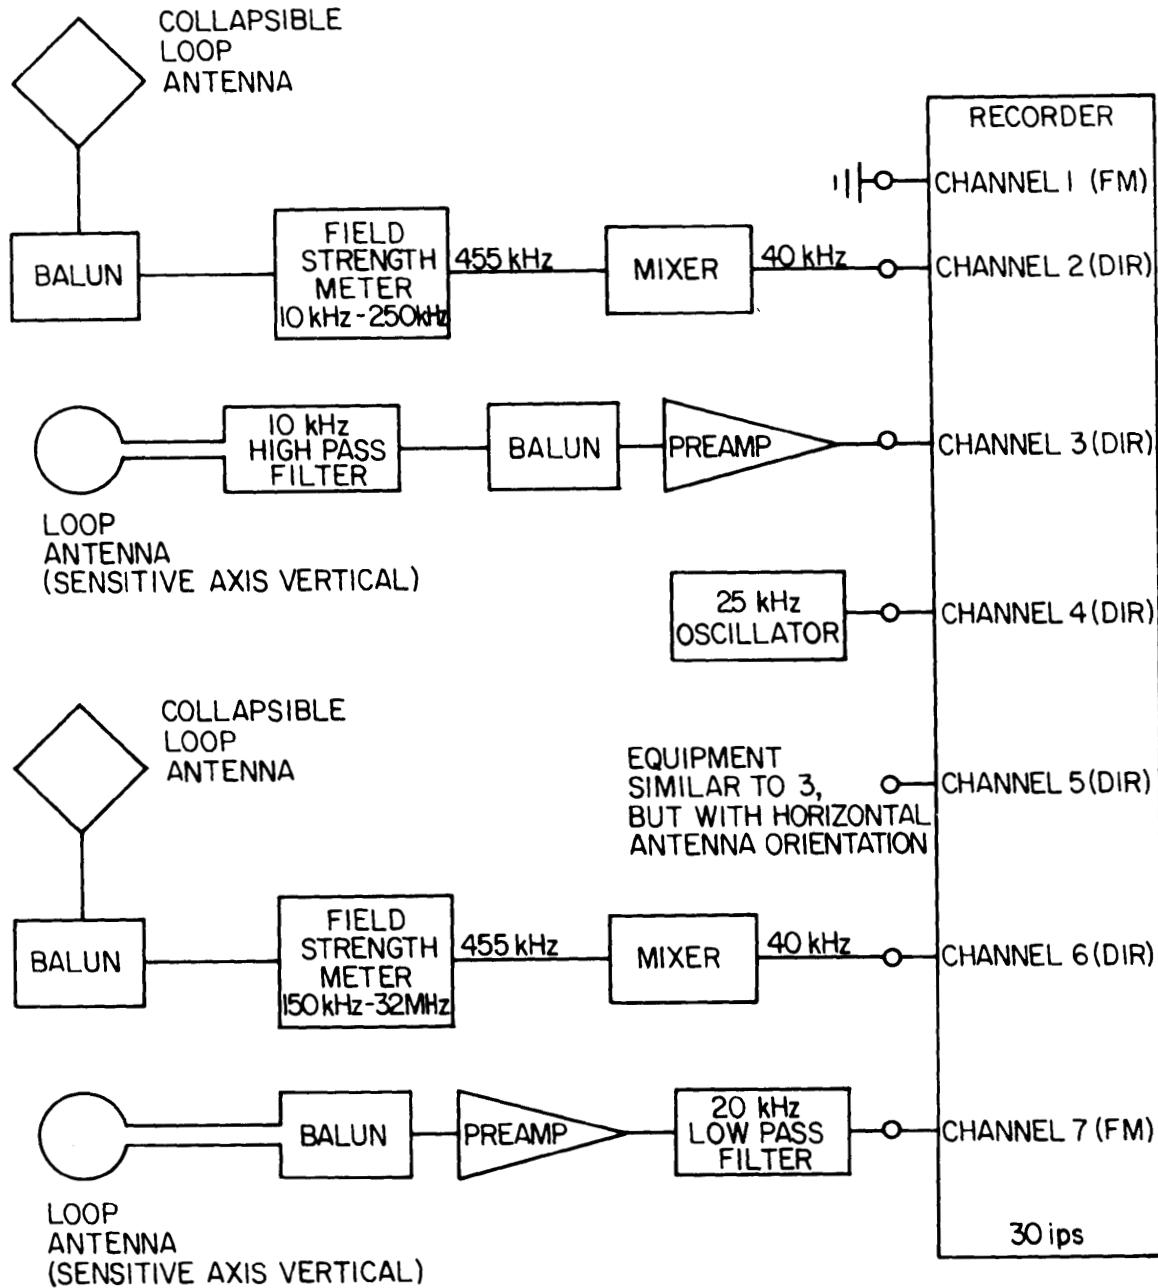
Figure 2-3 Block diagram of laboratory recording system modified for field use.

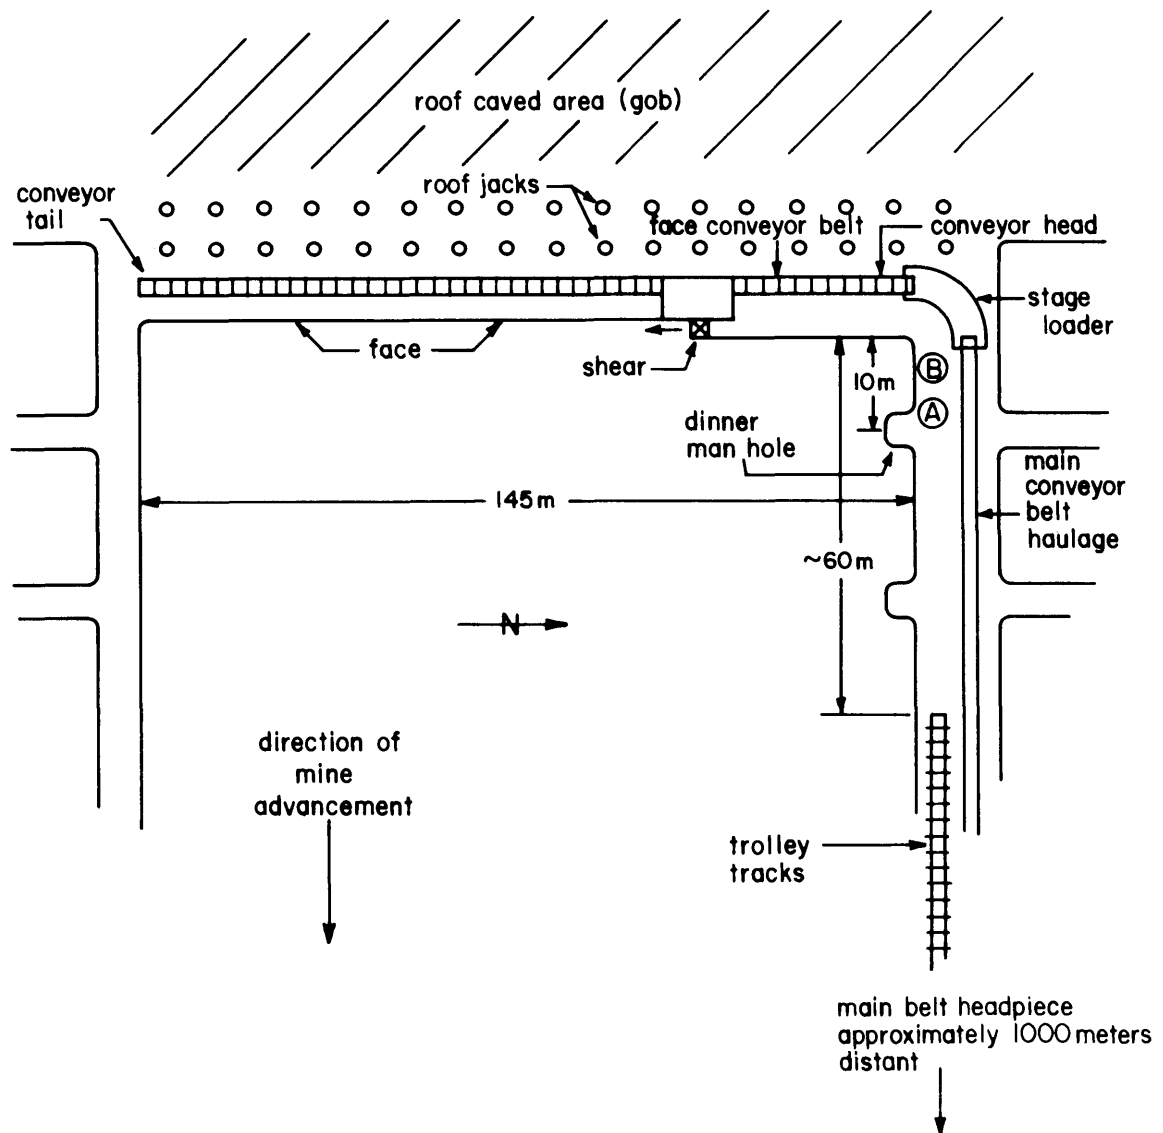
Figure 3-1 Map of Itmann Coal Mine, Cabin Creek panel long-wall mining section. Farley panel is a minor image of this section.

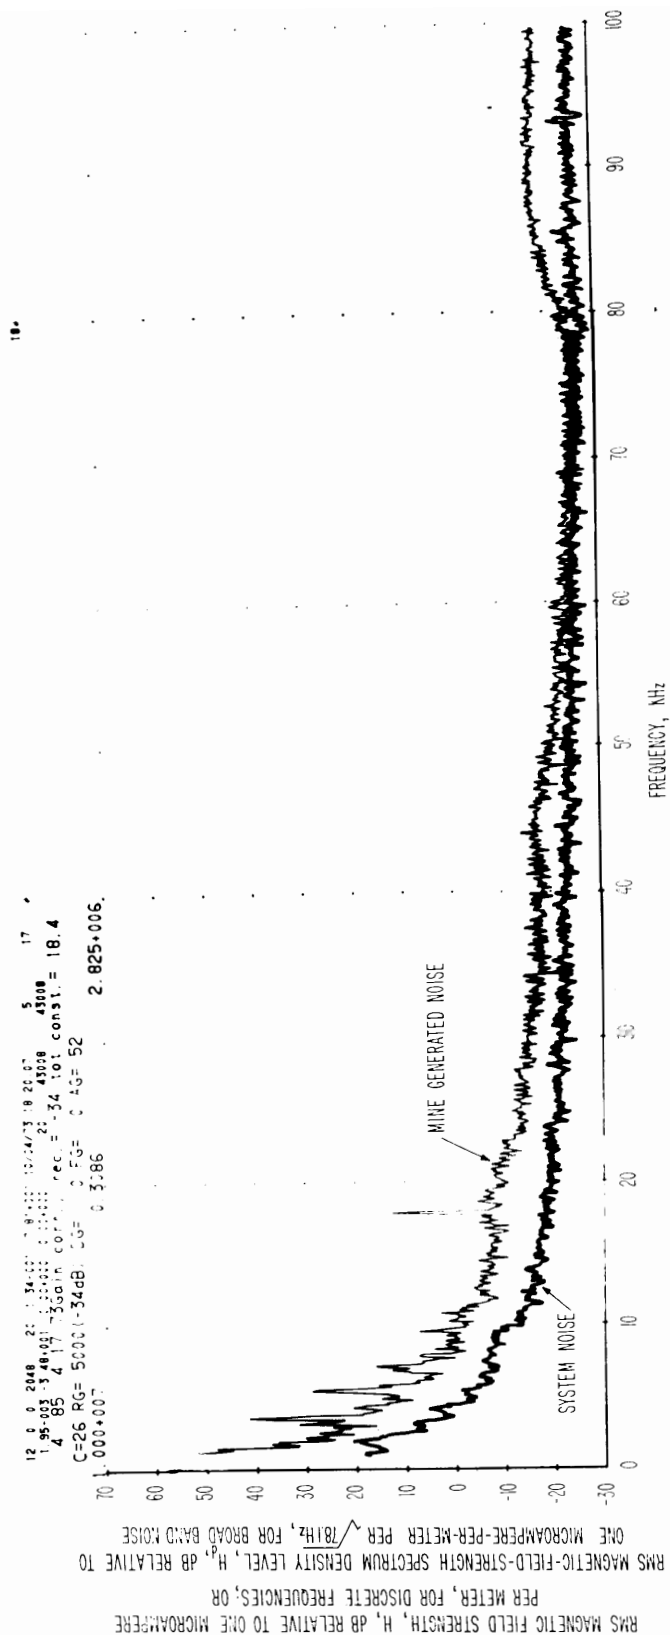
Figure 3-2 Composite spectrum of magnetic field strength obtained on a loop antenna 1 kHz to 100 kHz, Itmann Mine, Cabin Creek panel, 10 meters from the end of the long-wall face, mine in operation, antenna sensitive axis vertical, 12:10 p.m., April 17, 1973. Spectral resolution is 78.1 Hz.

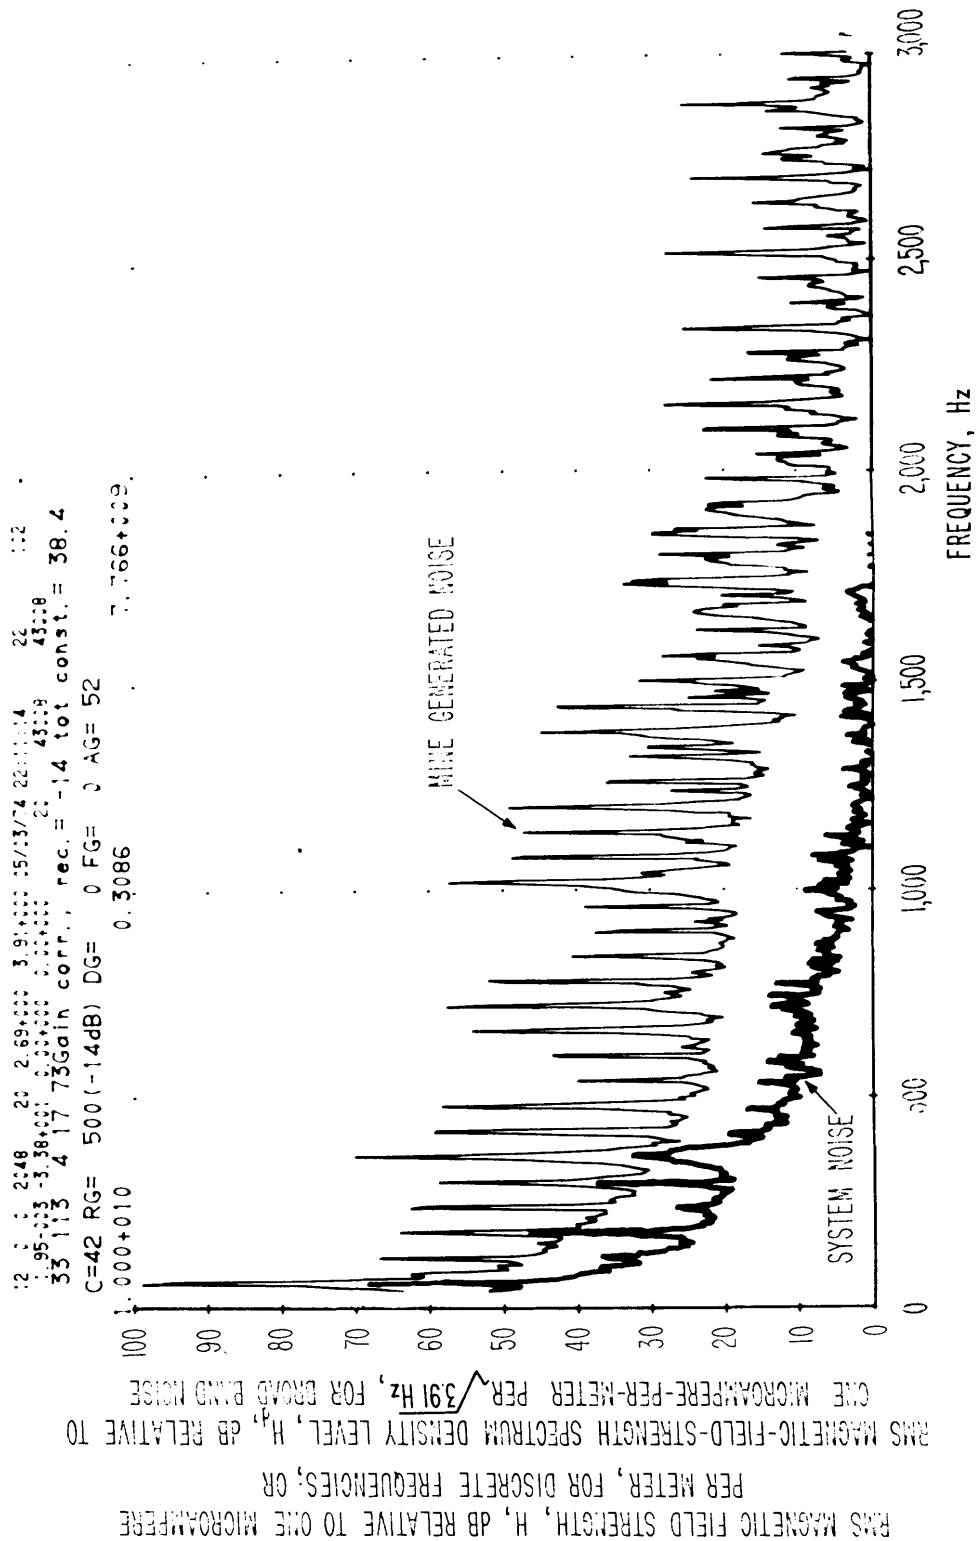
Figure 3-3 Spectrum of magnetic field strength obtained on a loop antenna 40 Hz to 3 kHz, Itmann Mine, Cabin Creek panel, 10 meters from the end of the long-wall face, mine in operation, antenna sensitive axis vertical, 12:10 p.m., April 17, 1973. Spectral resolution is 3.91 Hz.

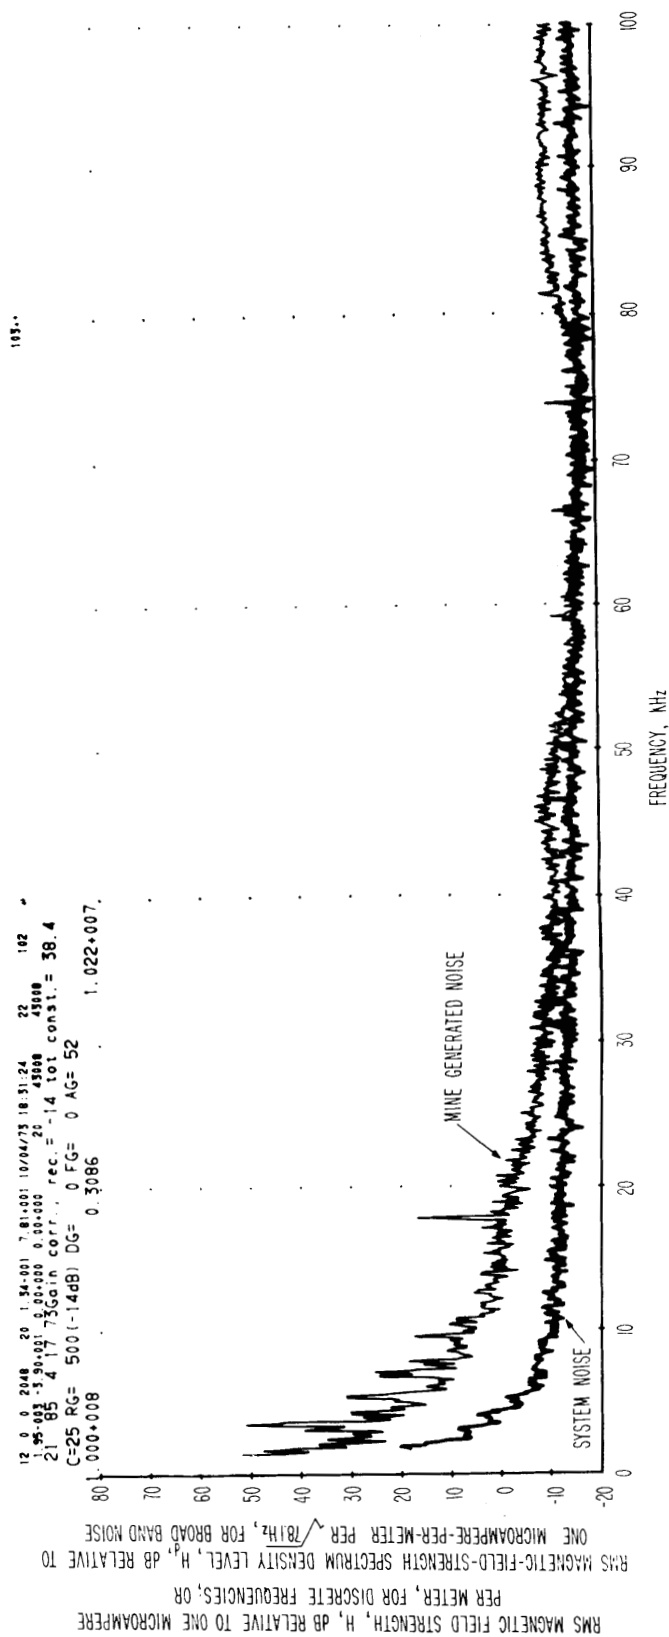
Figure 3-4 Spectrum of magnetic field strength obtained on a loop antenna 1 kHz to 100 kHz, Itmann Mine, Cabin Creek panel, 5 meters from the end of the long-wall face, mine in operation, antenna sensitive axis vertical, 3:17 p.m., April 17, 1973. Spectral resolution is 78.1 Hz.

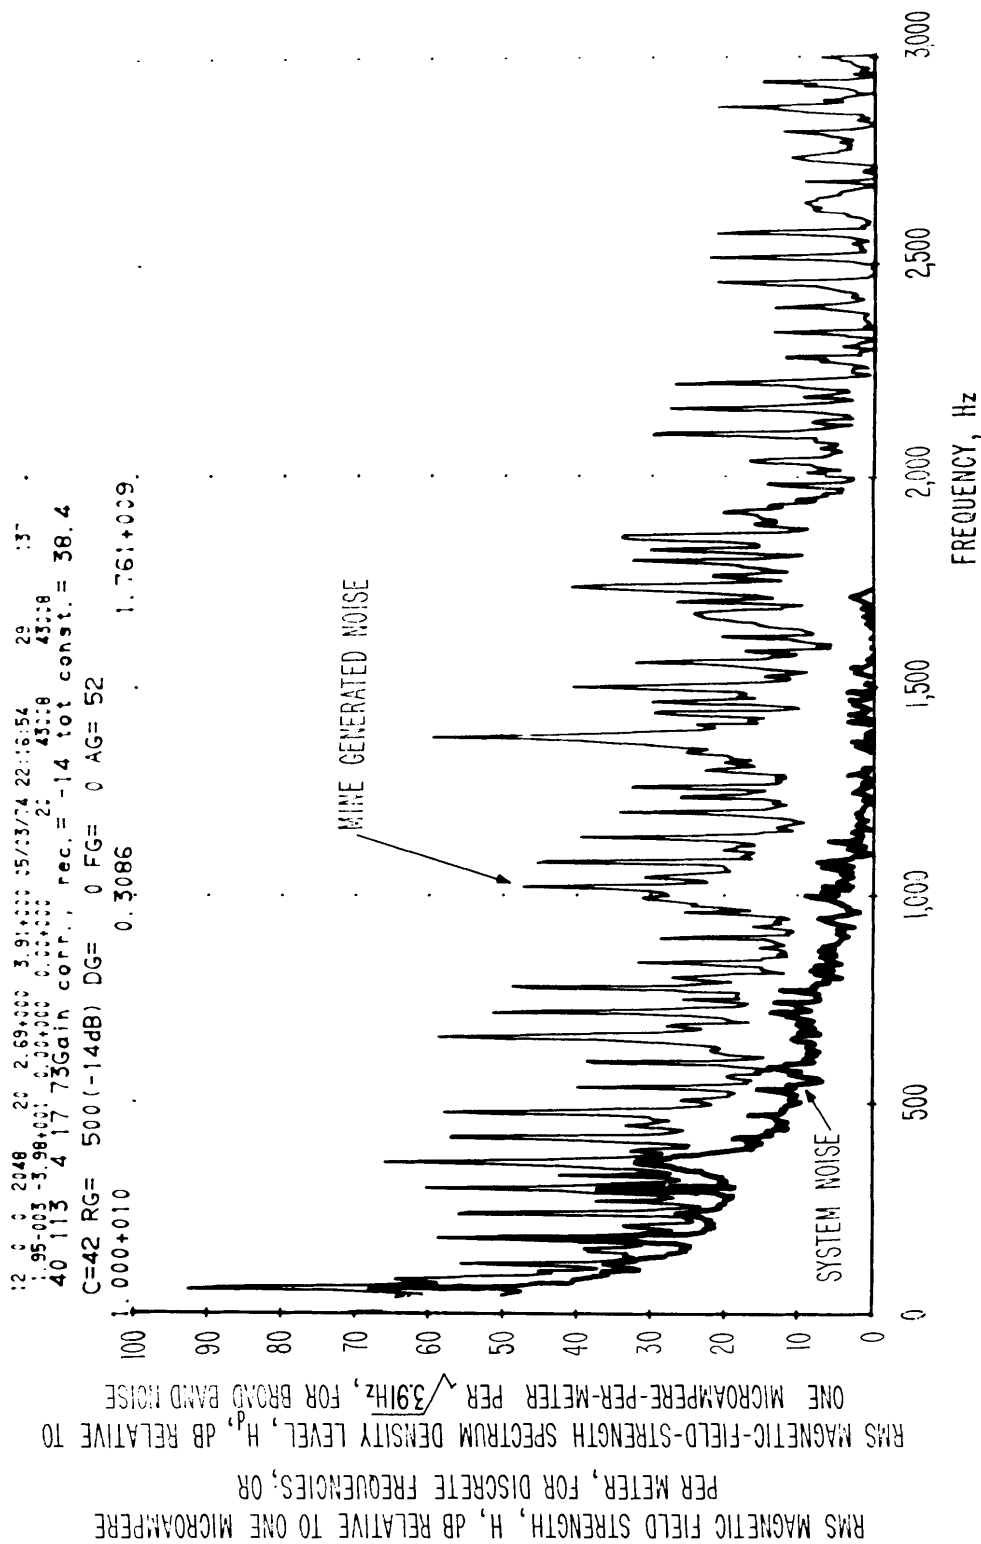
Figure 3-5 Spectrum of magnetic field strength obtained on a loop antenna 40 Hz to 3 kHz, Itmann Mine, Cabin Creek panel, 5 meters from the end of the long-wall face, mine in operation, antenna sensitive axis vertical, 3:17 p.m., April 17, 1973. Spectral resolution is 3.91 Hz.

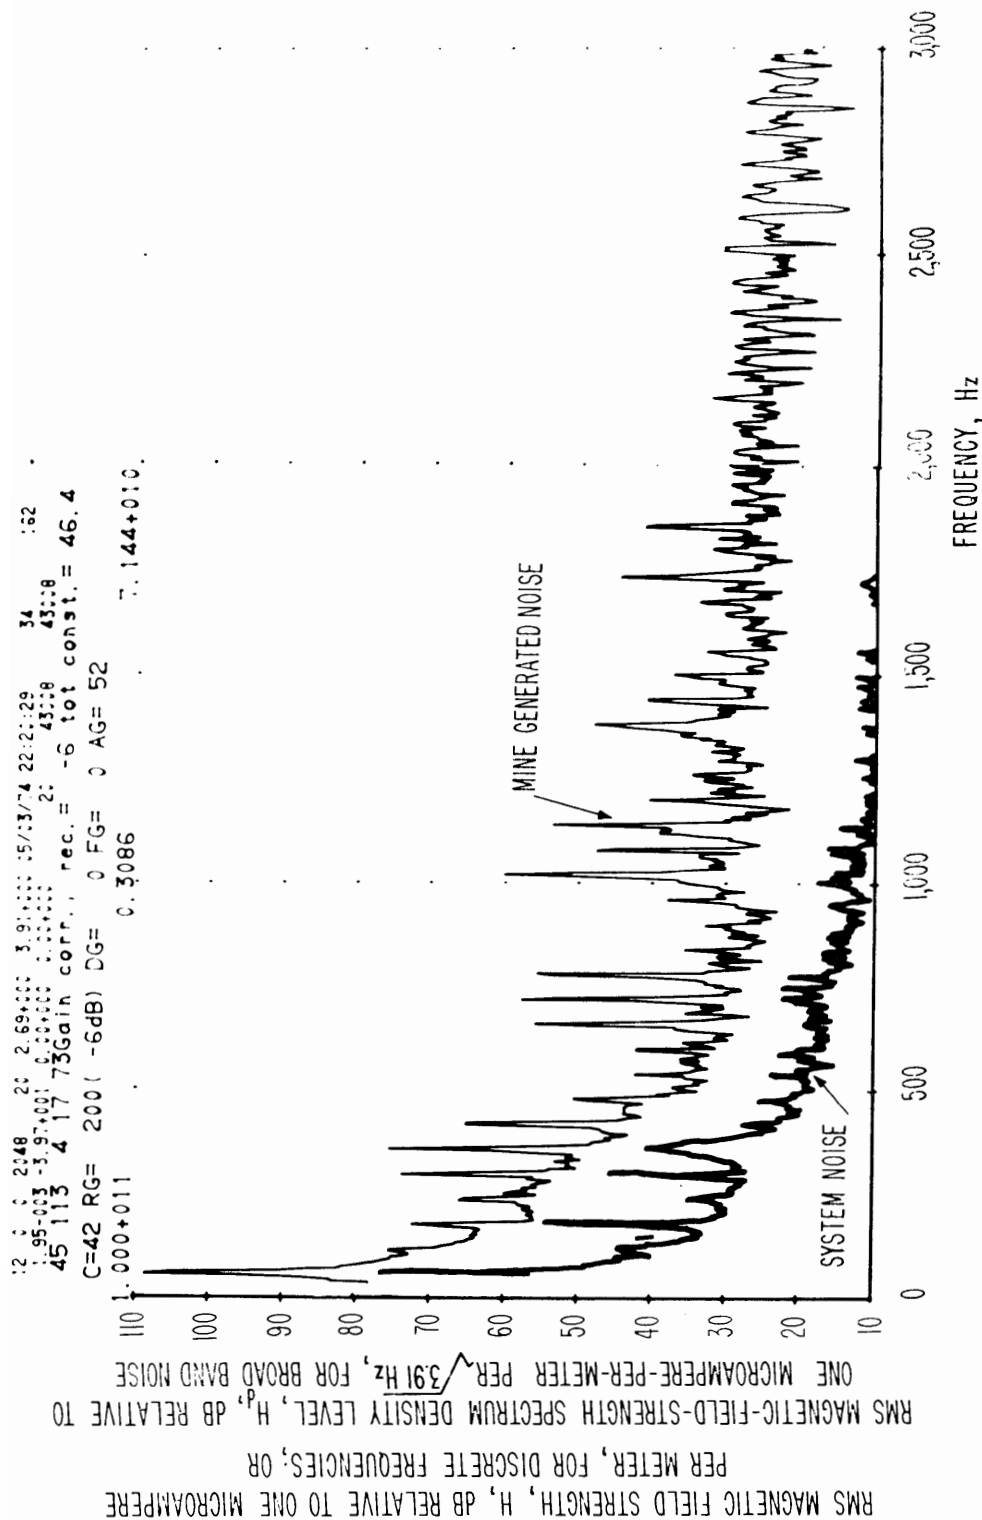
Figure 3-6 Spectrum of magnetic field strength obtained on a loop antenna 40 Hz to 3 kHz, Imman line, Cabin Creek panel, 5 meters from the end of the long wall face, second shift in full operation, antenna sensitive axis vertical, 4:55 a.m., April 17, 1974. Spectral resolution is 3.91 Hz.

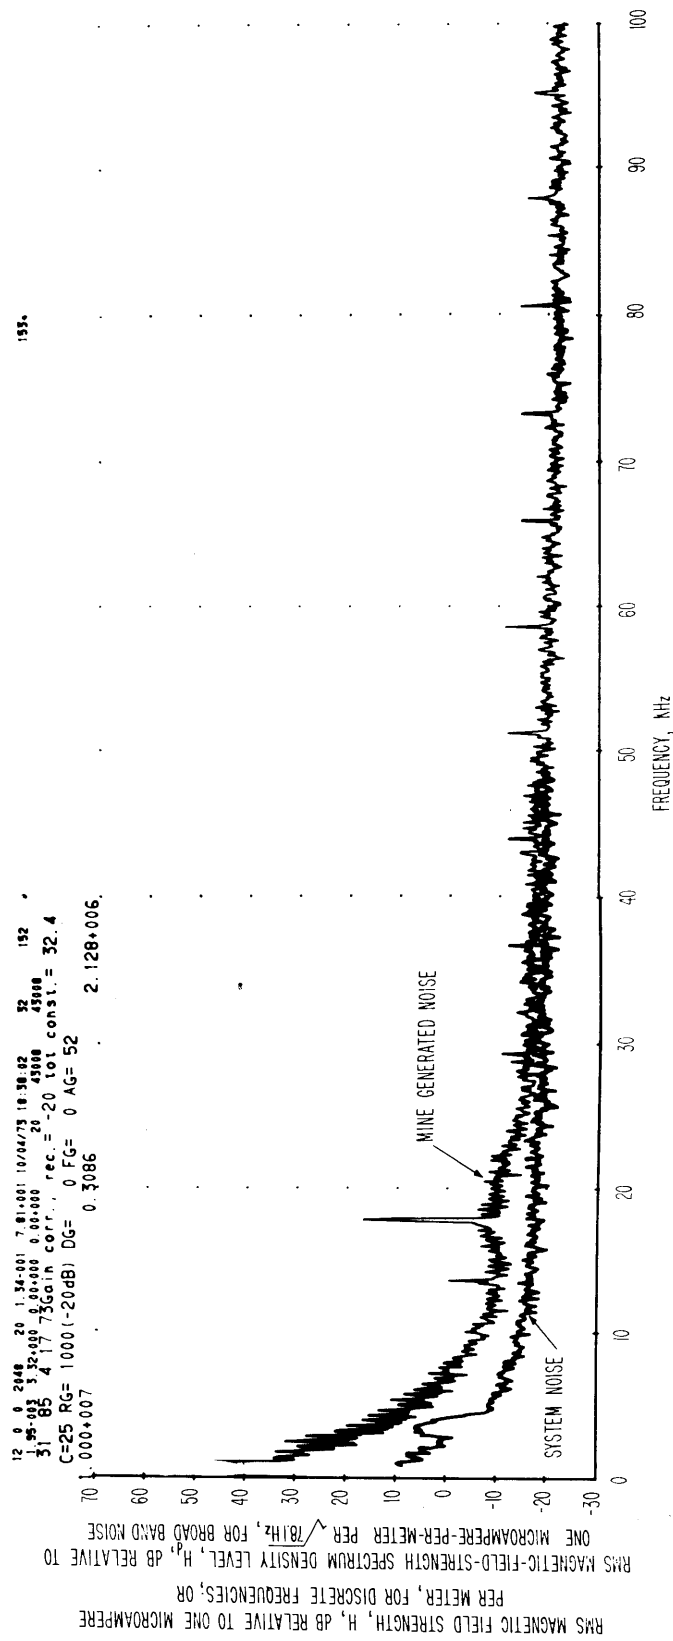
Figure 3-7 Spectrum of magnetic field strength obtained on a loop antenna 1 kHz to 100 kHz, Itmann Mine, Cabin Creek panel, 5 meters from long-wall face, quiet between shifts, antenna sensitive axis vertical, 3:57 p.m., April 17, 1974. Spectral resolution is 78.1 Hz.

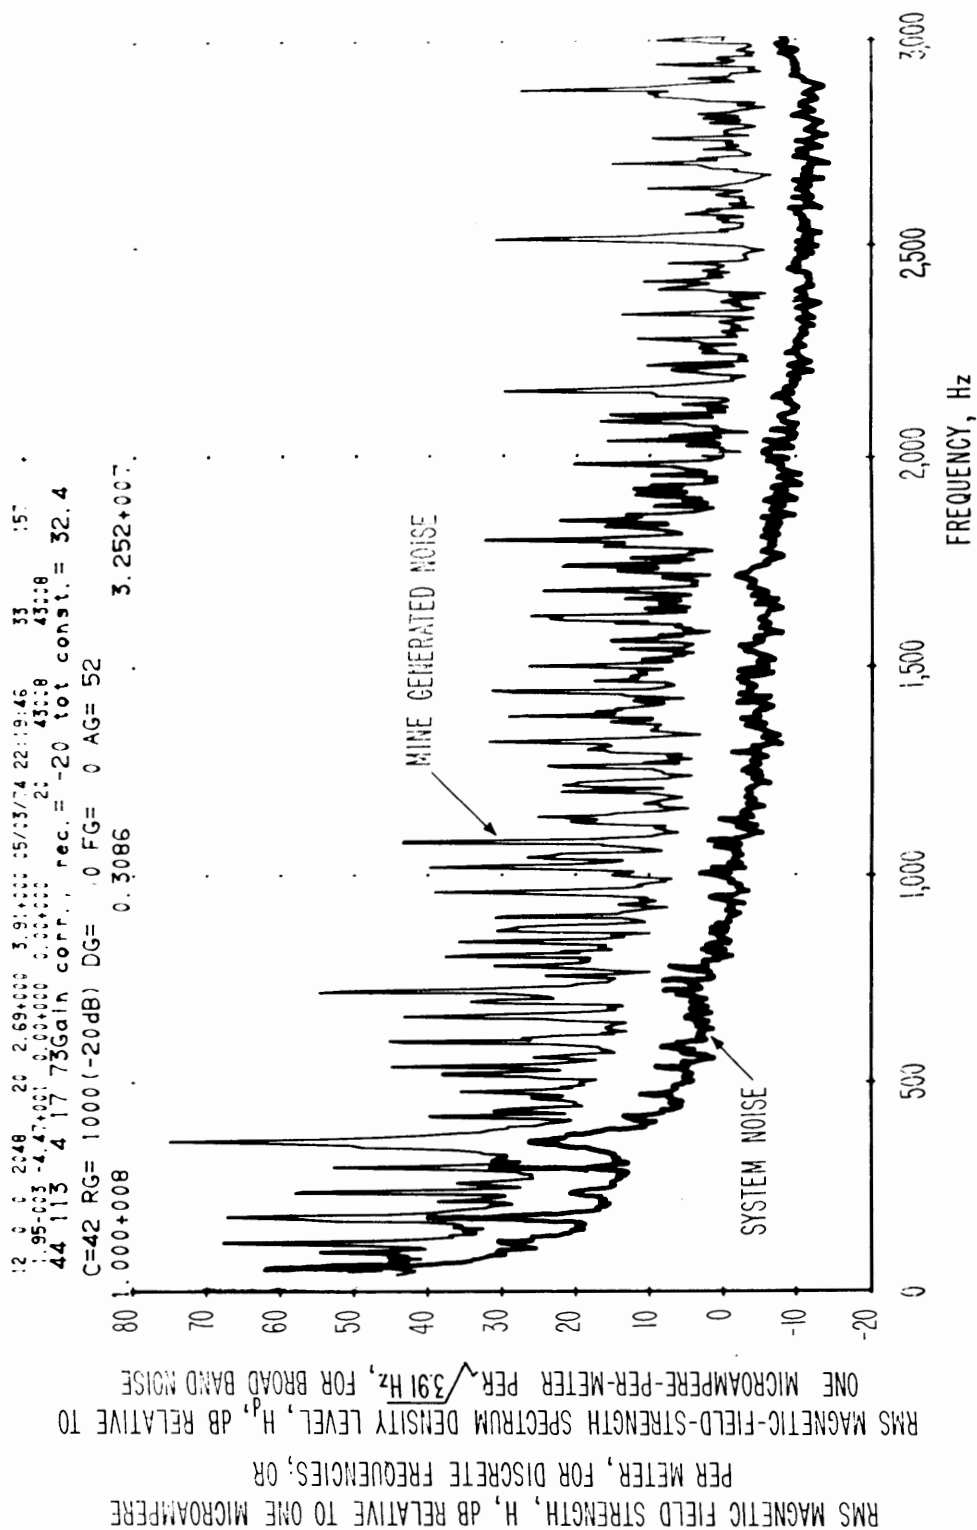
Figure 3-8 Spectrum of magnetic field strength obtained on a loop antenna 40 Hz to 3 kHz, Itmann Mine, Cabin Creek panel, 5 meters from long-wall face, quiet between shifts, antenna sensitive axis vertical, 3:57 p.m., April 17, 1974. Spectral resolution is 3.91 Hz.

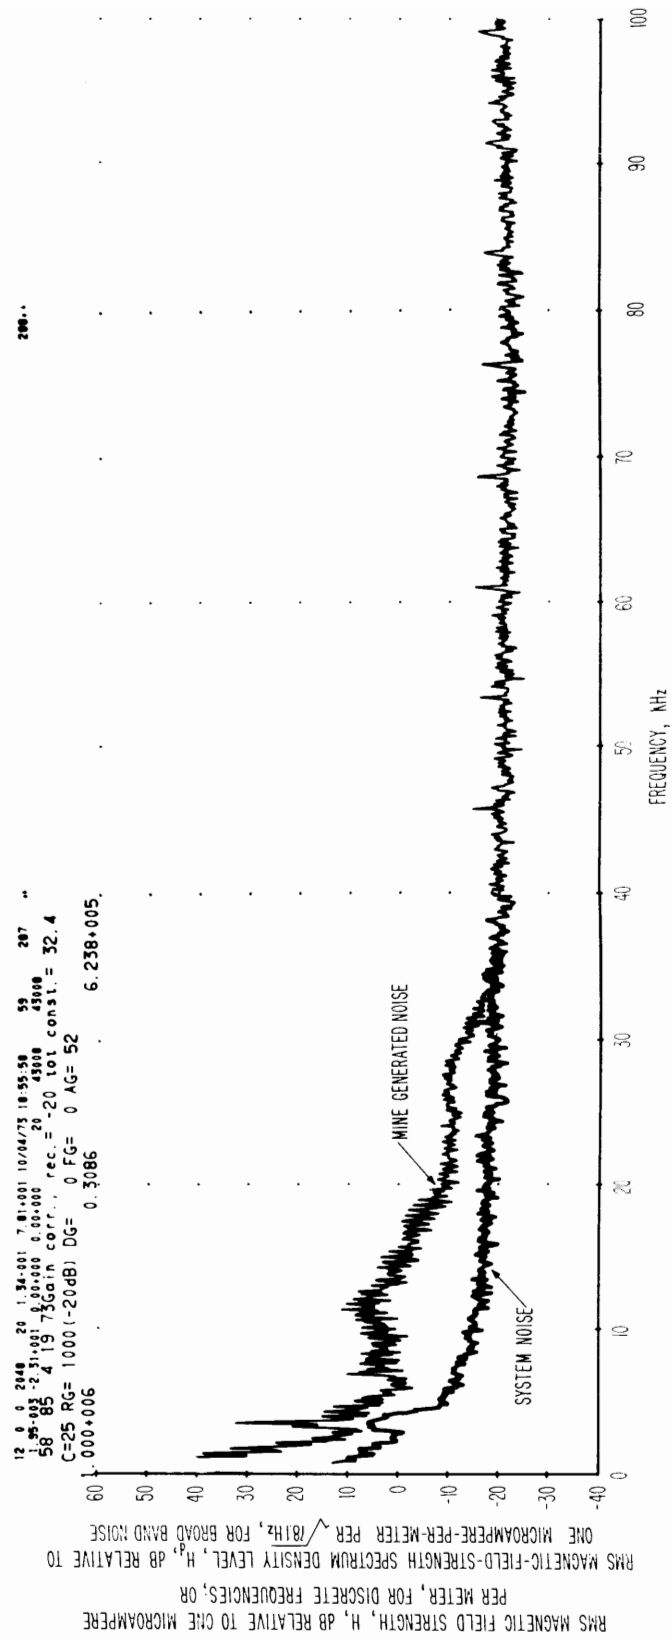
Figure 3-9 Spectrum of magnetic field strength obtained on a
 loop antenna 1 kHz to 100 kHz, Itmann Mine, Farley
 panel, 10 meters from the end of the long-wall face,
 mine in operation, antenna sensitive axis vertical,
 11:50 a.m., April 19, 1973. Spectral resolution
 is 78.1 Hz.

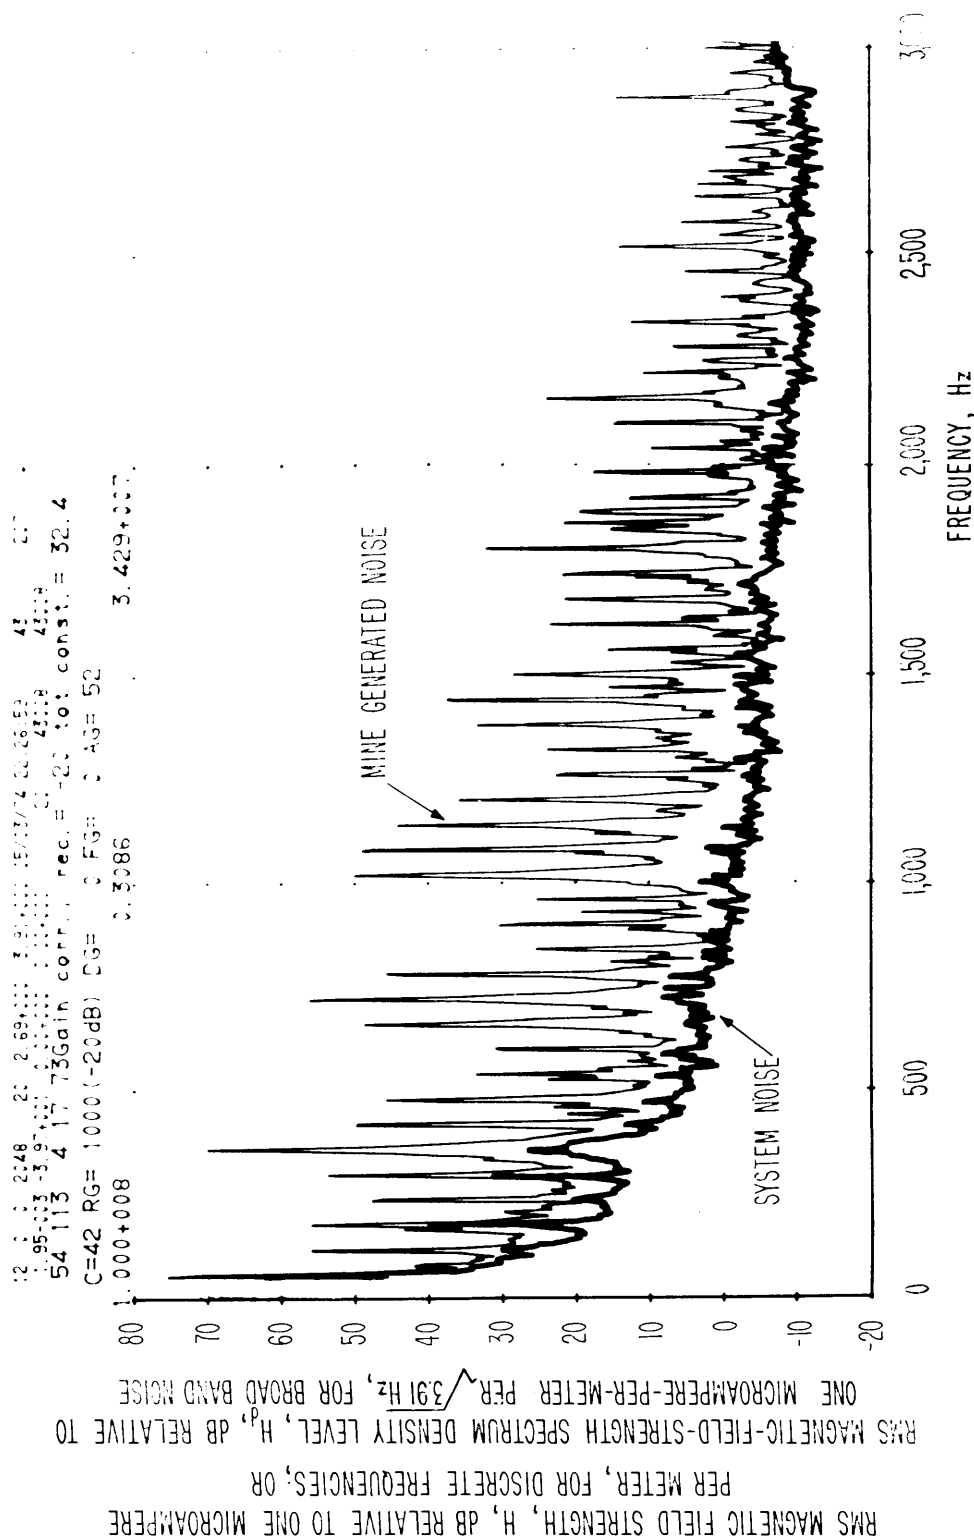
Figure 3-10 Spectrum of magnetic field strength obtained on a
 loop antenna 40 Hz to 3 kHz, Itmann Mine, Farley
 panel, 10 meters from the end of the long-wall
 face, mine in operation, antenna sensitive axis
 vertical, 11:50 a.m., April 19, 1973. Spectral
 resolution is 3.91 Hz.

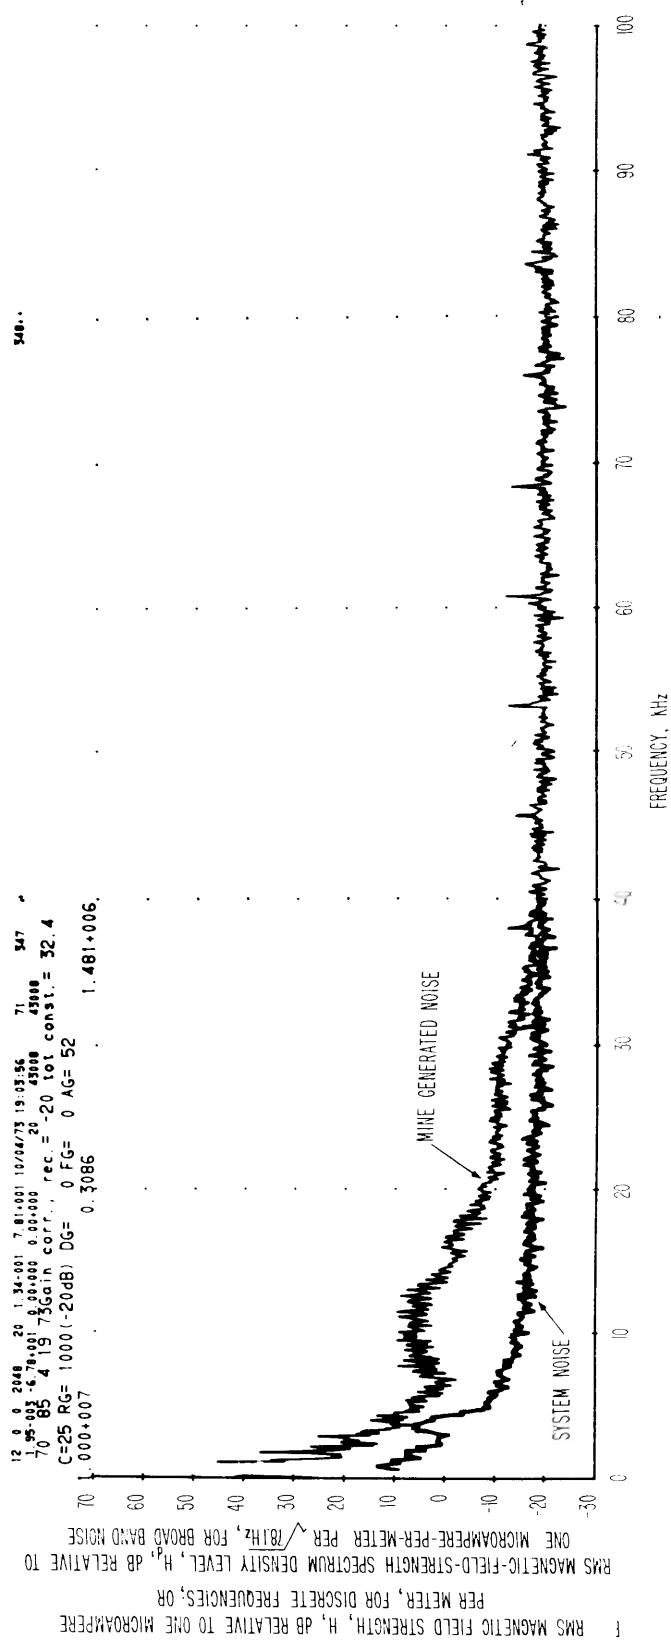
Figure 3-11 Spectrum of magnetic field strength obtained on a loop antenna 1 kHz to 100 kHz, Itmann Mine, Farley panel, 10 meters from the end of the long-wall face, only the hydraulic pump in operation, during lunch hour, antenna sensitive axis horizontal, 1:03 p.m., April 19, 1973. Spectral resolution is 78.1 Hz.

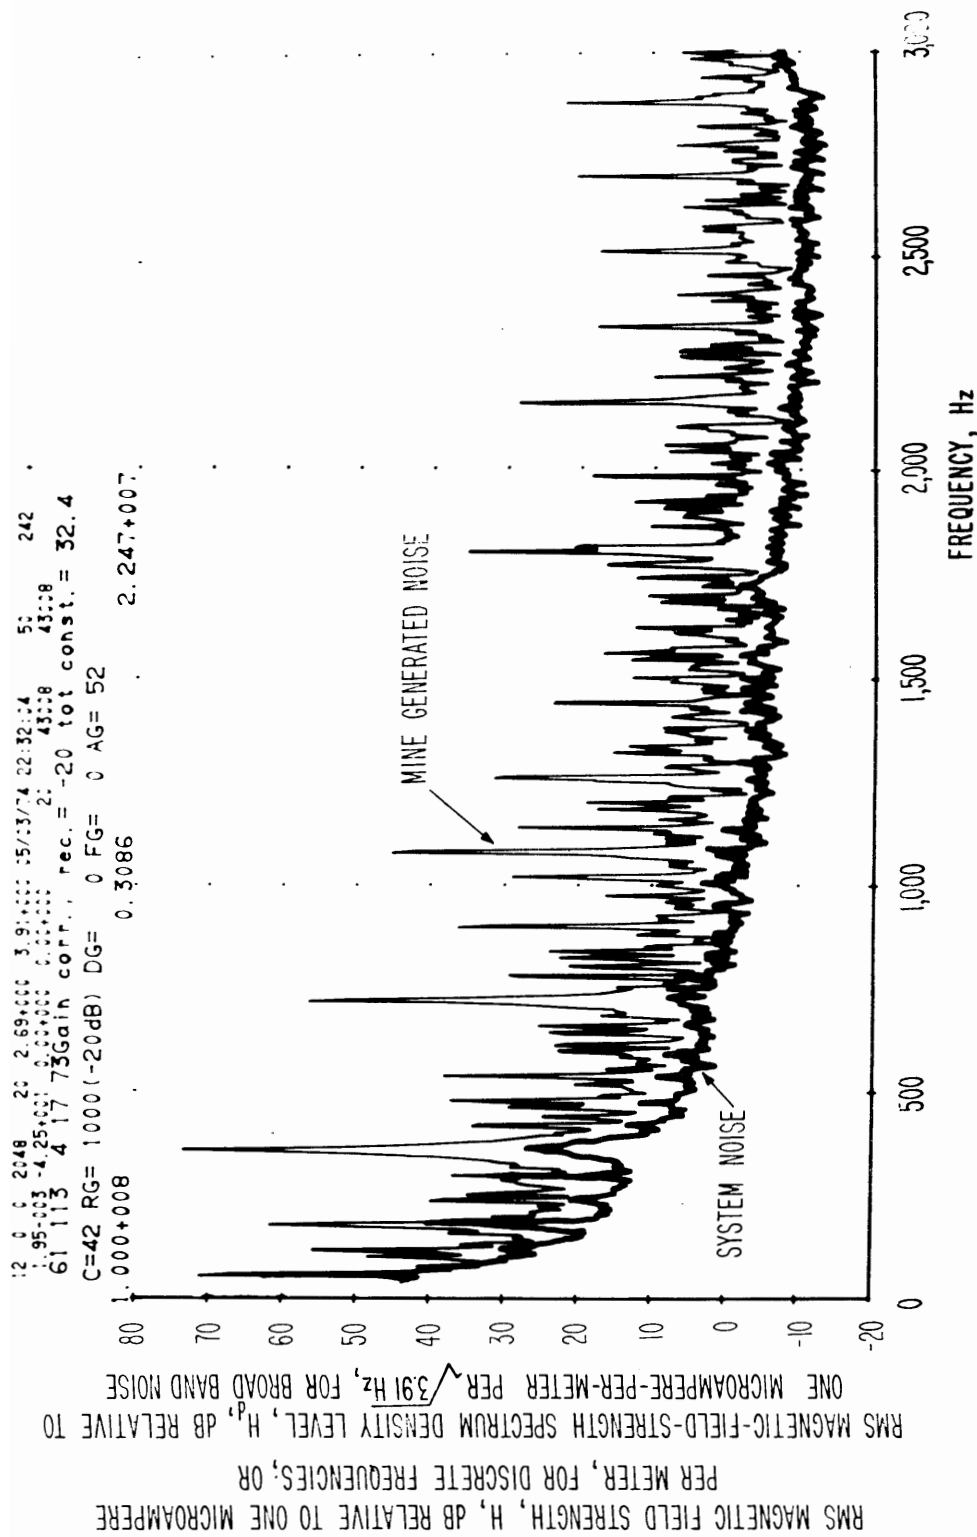
Figure 3-12 Spectrum of magnetic field strength obtained on a loop antenna 40 Hz to 3 kHz, Itmann Mine, Farley panel, 10 meters from the end of the long-wall face, only the hydraulic pump in operation, during lunch hour, antenna sensitive axis horizontal, 1:03 p.m., April 19, 1973. Spectral resolution is 3.91 Hz.

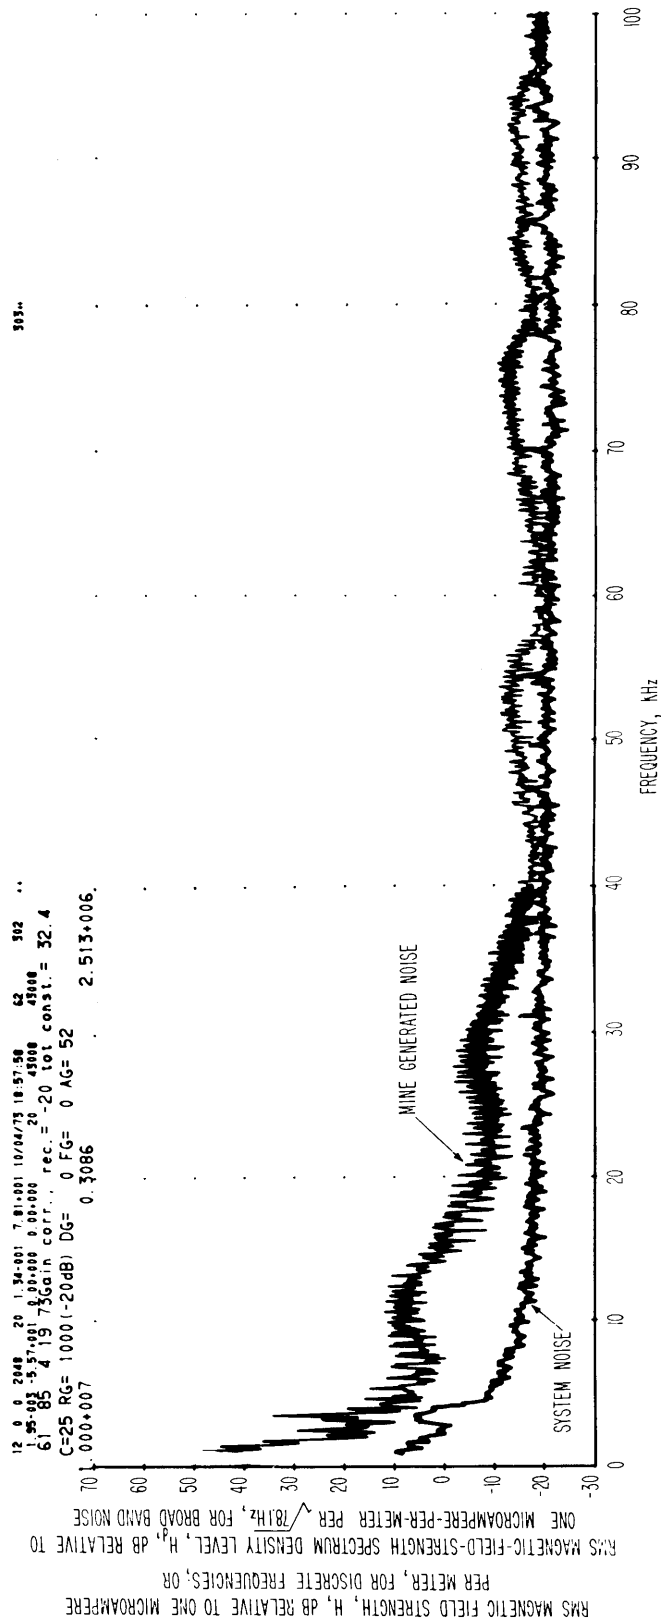
Figure 3-13 Spectrum of magnetic field strength obtained on a
 loop antenna 1 kHz to 100 kHz, Itmann Mine, Farley
 panel, 10 meters from the end of the long-wall
 face, conveyor belt starting up, antenna sensitive
 axis vertical, 12:42 p.m., April 19, 1973. Spectral
 resolution is 78.1 Hz.

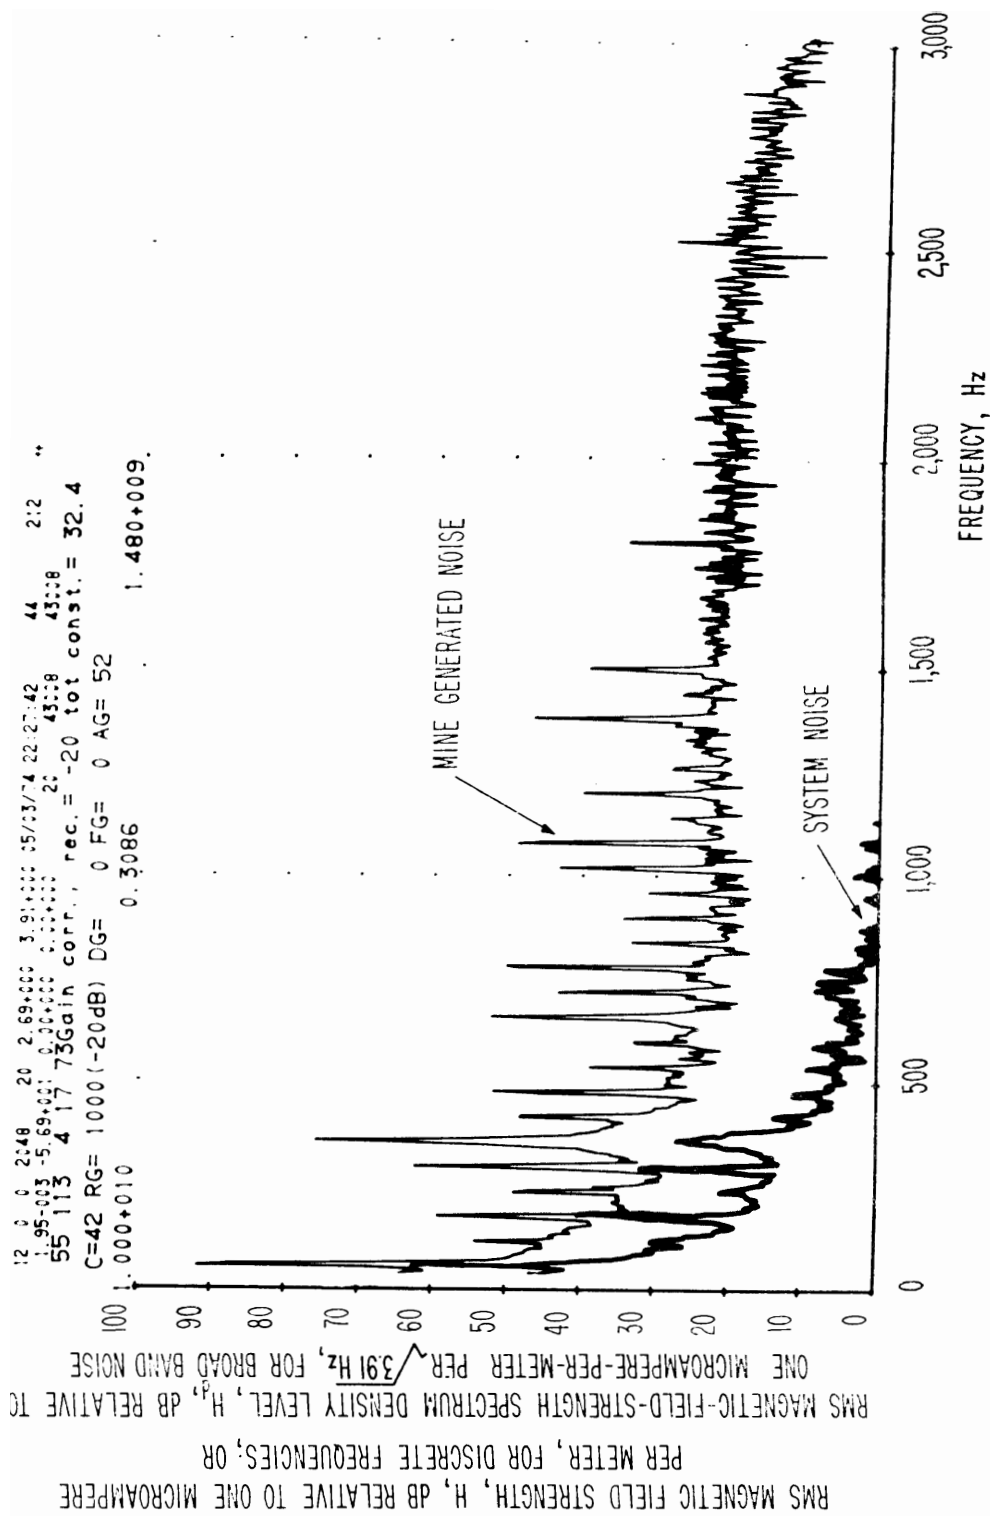
Figure 3-14 Spectrum of magnetic field strength obtained on a loop antenna 40 ft to 3 klz, Itman Mine, Farley panel, 10 meters from the end of the long-wall face, conveyor belt starting up, antenna sensitive axis vertical, 12:42 p.m., April 19, 1973. Spectral resolution is 3.91 Hz.
